DEPARTMENT OF TRANSPORTATION

Contract #: 04-0120F4Cty: SF/ALA Rte: 80 PM: 13.2/13.9File #: 1.28**WELDING INSPECTION REPORT****Resident Engineer:** Casey, William**Address:** 333 Burma Road**City:** Oakland, CA 94607**Report No:** WIR-028557**Date Inspected:** 01-Oct-2012**Project Name:** SAS Superstructure**OSM Arrival Time:** 700**Prime Contractor:** American Bridge/Fluor Enterprises, a JV**OSM Departure Time:** 1530**Contractor:** American Bridge/Fluor Enterprises, a JV**Location:** Job site**CWI Name:** Harry Scharein**CWI Present:** Yes No**Inspected CWI report:** Yes No N/A**Rod Oven in Use:** Yes No N/A**Electrode to specification:** Yes No N/A**Weld Procedures Followed:** Yes No N/A**Qualified Welders:** Yes No N/A**Verified Joint Fit-up:** Yes No N/A**Approved Drawings:** Yes No N/A**Approved WPS:** Yes No N/A**Delayed / Cancelled:** Yes No N/A**Bridge No:** 34-0006**Component:** OBG**Summary of Items Observed:**

OBG 13W Deck Drop-in (DAH-13W-PP124.5-W5)

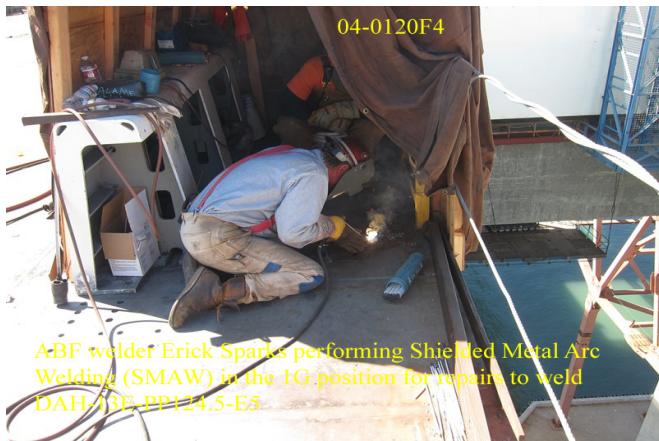
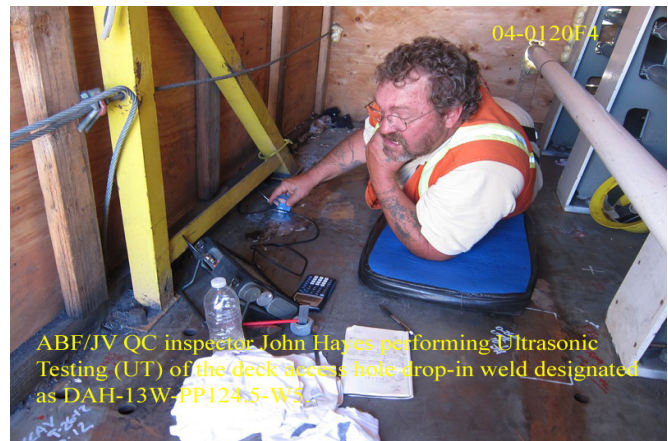
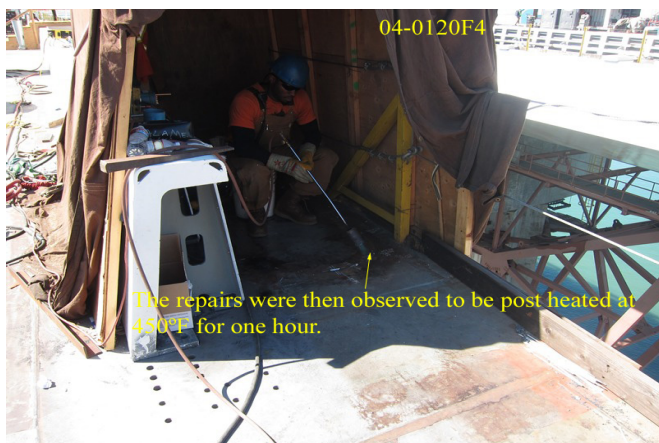
The QAI noted and periodically observed ABF welder Erick Sparks performing Shielded Metal Arc Welding (SMAW) in the 1G position utilizing the Caltrans approved Welding Procedure Specifications ABF-WPS-D1. 5-1004-Repair. The weld was excavated and magnetic particle testing performed on a previous shift. The repairs are located on the deck access hole drop-in weld for lift 13E between panel point 124 and 124.5 at the following locations;

The weld and surrounding area was brought to a temperature of 325°F by the use of a gas torch and maintained throughout the welding process. The repairs were then observed to be post heated at 450°F for one hour. The repair excavations were performed in accordance with the following approval for repair documents;

This QA randomly observed ABF/JV QC inspector John Hayes performing Ultrasonic Testing (UT) of the deck access hole drop-in weld designated as DAH-13W-PP124.5-W5. The locations Ultrasonically tested were in way of repairs performed and completed 24 hours prior. The following locations were tested;

Y=2490 One rejectable indication observed by QC.
